Technical Memo

**Re: COWICHAN LAKE SHORELINE ASSESSMENT
2020 Present Natural Boundary at Cowichan Lake**

This technical memo describes the field survey and related assessment of the present (2020) natural boundary around Cowichan Lake. This work is part of Cowichan Valley Regional District's Cowichan Lake Shoreline Assessment study led by KWL.

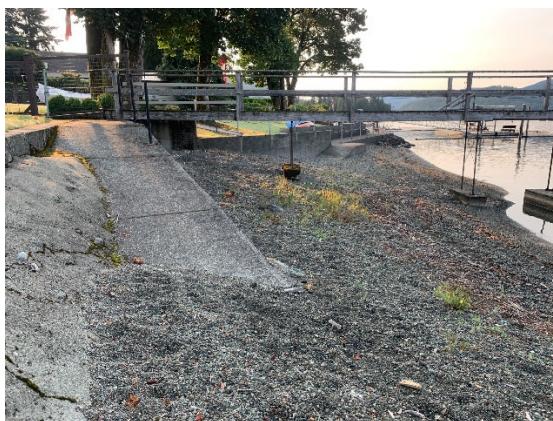
Photo 1: Concrete PNB

In the developed areas of the lake, comprising about 40 kilometres of shoreline, the determination of the PNB was complicated by manmade changes. Removal of native vegetation and alteration of the contours through filling and construction of retaining walls obscured the original location of the PNB in many areas. In these areas, ties were made to places where the PNB appeared to be undisturbed, as indicated by mature trees and other vegetation. Where possible, ties were also made to retaining walls and concrete structures so that they could be identified later in the office.

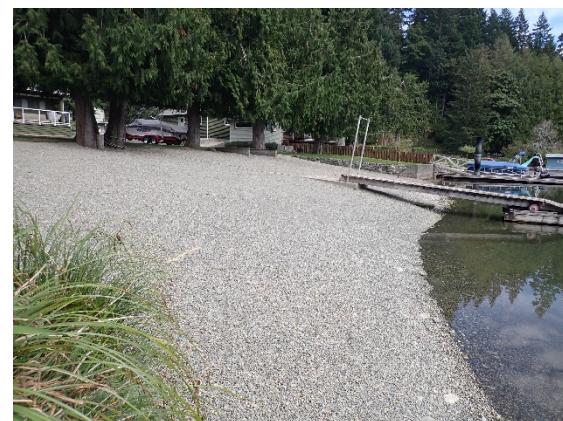
Photo 2: Natural Vegetation Removed

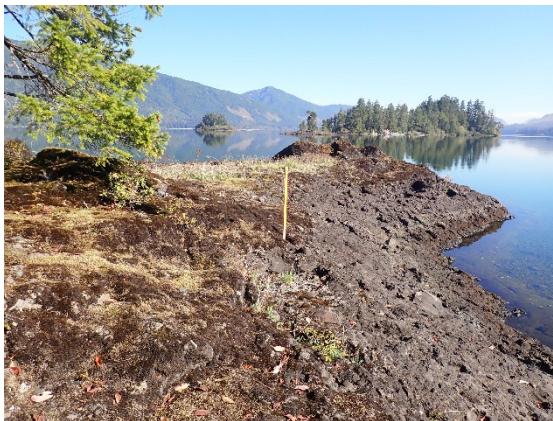
Photo 3: Moss line on bedrock

Generally, along each section of lake shore where the aspect, topography, substrate, and vegetation were similar, the elevation of field tied PNB points was found to be within a narrow range. An average elevation was determined for each section with similar characteristics and the PNB was drawn in as a splined line joining the tied points and points along the average elevation contour using the LiDAR surface. As the line was being drawn the orthophoto layer was used to confirm physical cues such as the edge of vegetation, the line of driftwood and the change in soil characteristics were also considered. The level of detail available in the orthophoto imagery was quite useful. For example, in bare rocky areas the line of moss and lichens was quite visible and verified by reference to the ground photos taken at the time of the survey.

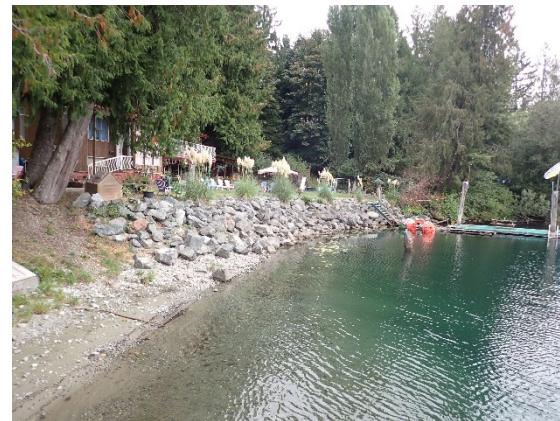
Photo 4: Riprap and fill
